McElwee Building
208 8th Street (Main Street)
Marlinton
Pocahontas County
West Virginia

HABS No. WV-234

ARCHITECTURAL DATA FORM

McELWEE'S STORE BUILDING

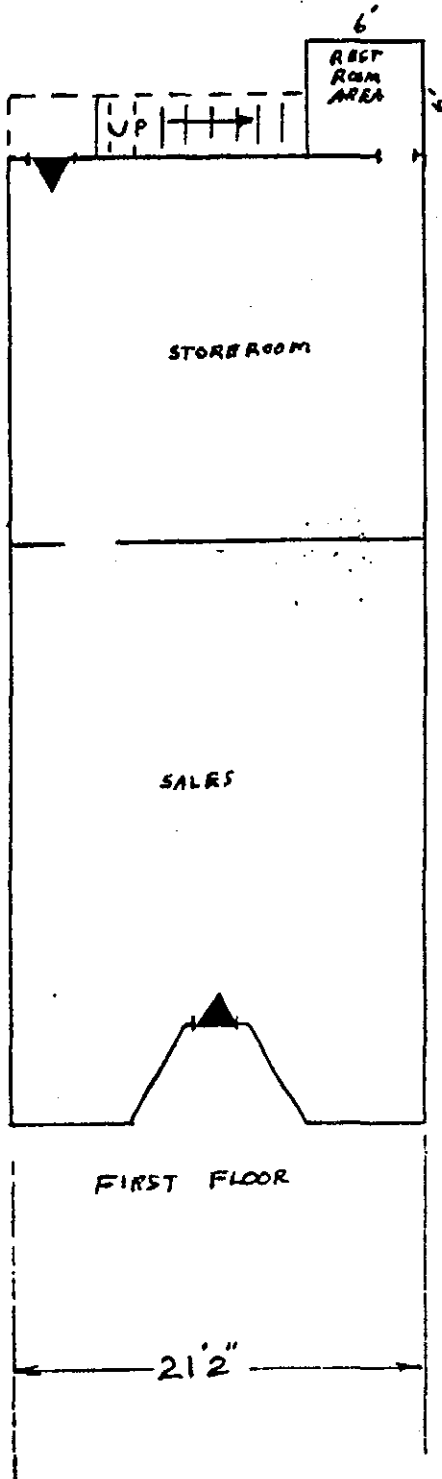
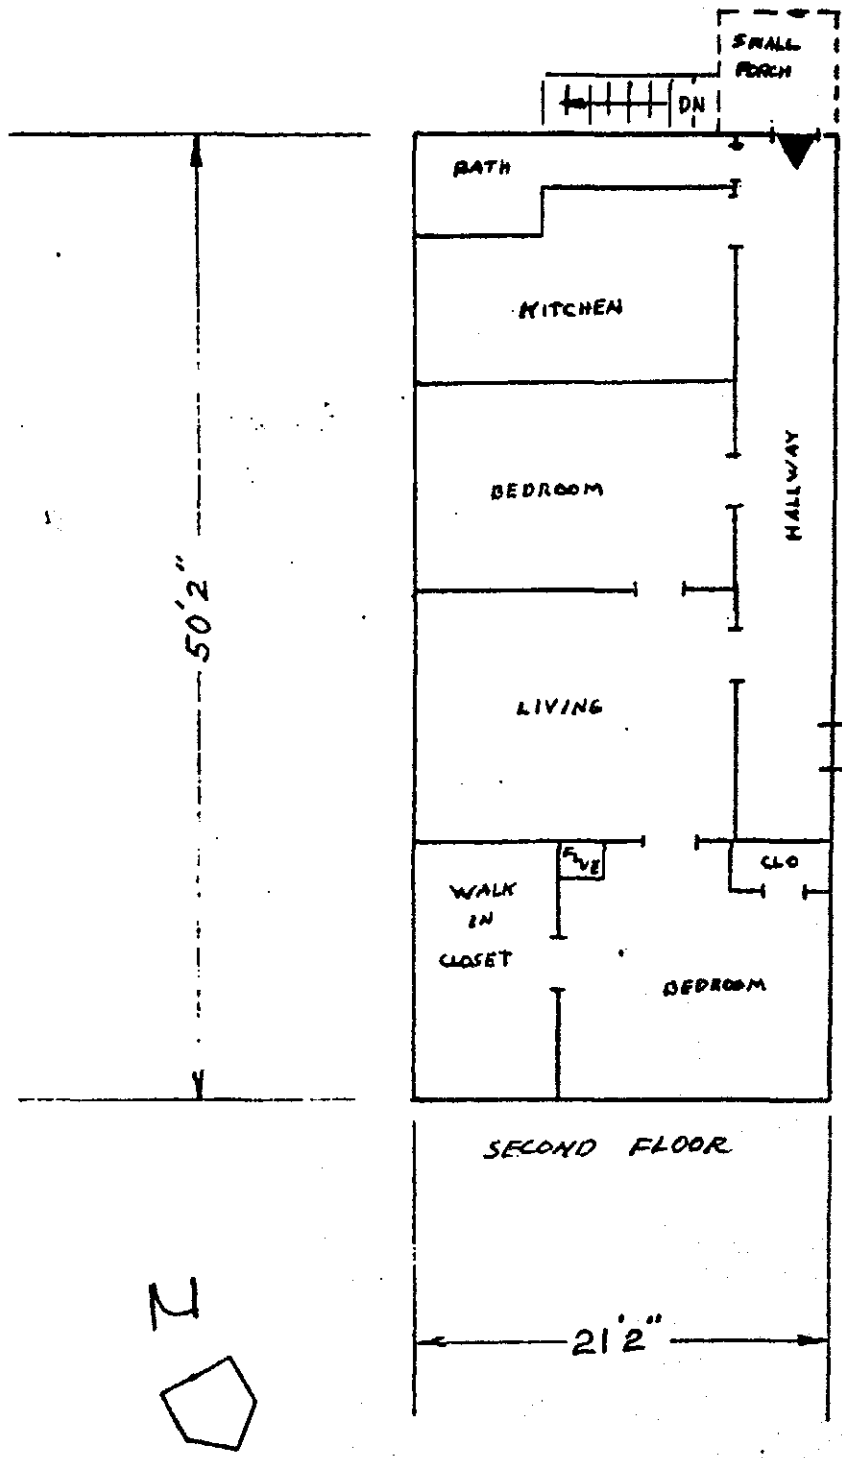
McELWEE BUILDING
HABS No. WV- 234 (page 6)

By actual field measurements the structure, on the main floor is 21'2" X 50'2" plus a 6'2" X 6'2" offset, and contains 1099 rnd, sq.ft., the second floor measures 21'2" X 50'2", and contains 1061 rnd, sq.ft. for a total of 2160 sq.ft. on both floors.
